# Manhole Inspection Summary

Manhole # S47II\_033MH

Insp Date: **5/1/08 6:52 AM**

**Location** Address: **Montford Ave**

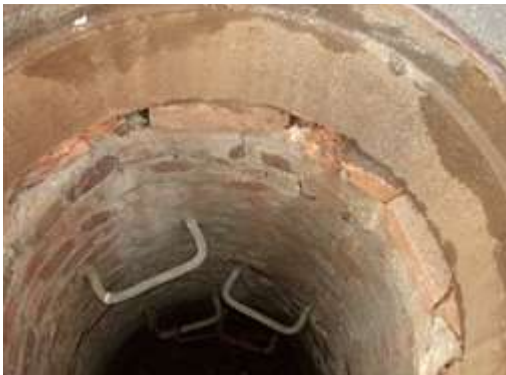
Defect 1

Condition: ☐ Sound ☐ Cracked ☐ Root Intrusion ☒ **Loose Brick** ☒ **Deteriorated**

Infiltration: ☐ None ☐ Joint ☐ Cracks ☒ **Mortar** ☐ Roots ☐ Wall

Loose Bricks

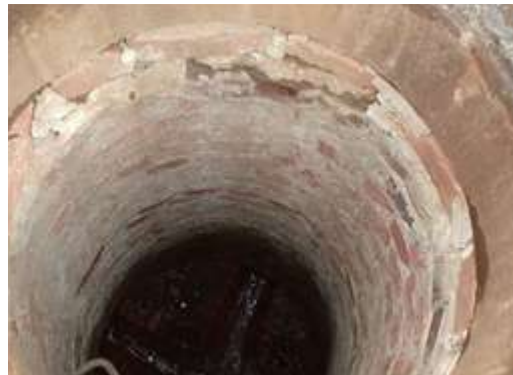
Defect 2

Deterioration

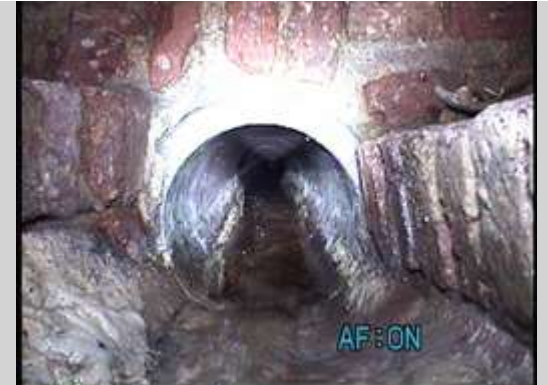
12 O'Clock Outflow

8 in. Circular Gravity Sewer  
Pipe Out @ 12 O'Clock

Pipe Height: **8.4** (in.) Rod and Bar (Angled)  
Pipe Material: **Clay** ☐ Pipe Lined  
Invert Depth: **10.05** (ft.) Flow Characteristics: **Fast**  
Deposits: ☒ None ☐ Mud ☐ Sludge ☐ Debris ☐ Grease  
Silt Depth: (in.) Deposits Extent:  
Infiltration: **None** Pipe Seal Cond: **Sound**

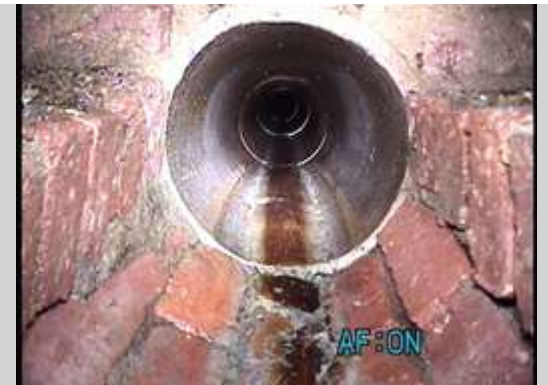
6 O'Clock Inflow

8 in. Circular Gravity Sewer  
Pipe In @ 6 O'Clock

Pipe Height: **8.4** (in.) Rod and Bar (Angled)  
Pipe Material: **Clay** ☐ Pipe Lined  
Invert Depth: **9.65** (ft.) Flow Characteristics: **Fast**  
Deposits: ☒ None ☐ Mud ☐ Sludge ☐ Debris ☐ Grease  
Silt Depth: (in.) Deposits Extent:  
Infiltration: **None** Pipe Seal Cond: **Sound**

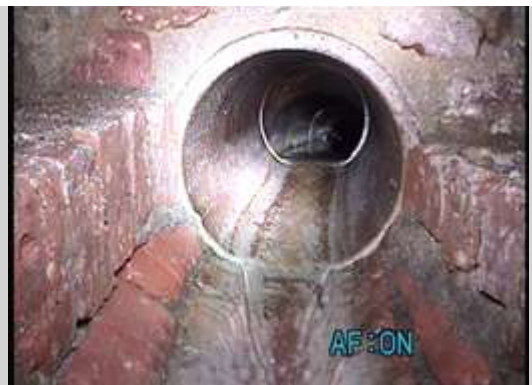
9 O'Clock Inflow

8 in. Circular Gravity Sewer

Pipe In @ 9 O'Clock

Pipe Height: **8.4** (in.) Rod and Bar (Angled)

Infiltration: **None** Pipe Seal Cond: **Sound**
